## **Influence of Rework on Road Projects in Ghana: A Case of the Sawla – Ffulso Road**

*Joseph ANNOR-ASUBONTENG<sup>1</sup>, Calistus TENGAN<sup>1</sup>, Kwame B.O. AMOAH<sup>2</sup>*

## **American Journal of Engineering, Science and Technology (AJEST)**

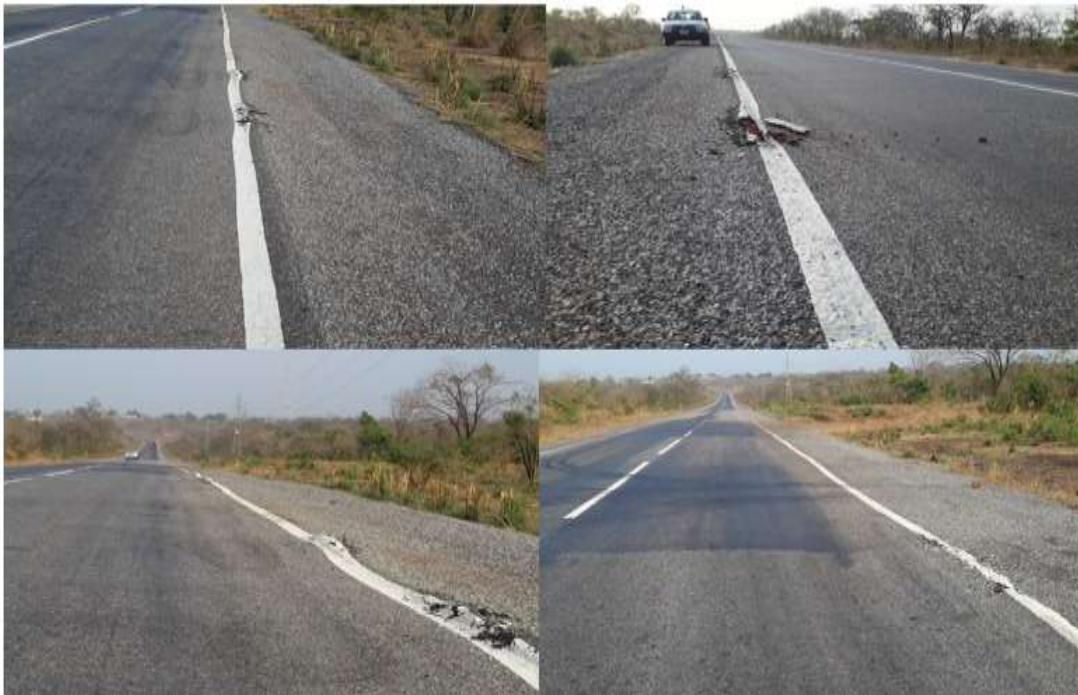
**Figure 1.** Illustrates some of the defective works executed by the contractor due to poor supervision and the lack of adequate understanding of the contract documents.

The hand of lots 1 and 2 handed over on 25th August 2015, which means that the Defect Liability period contractually was on 24th August 2016. However, a joint inspection conducted Client's, site, the Engineer's Representative, and representatives of the two contractors revealed a lot of significant defects that thought to be corrected especially on Lot 2. The situation on the ancillaries for Lot 2 per the interview conducted for this research was very alarming. The GHA team suggested taking over the Roads without the ancillary works to enable the Contractor to rectify the ancillary works' defects. However, by GHA's suggestion was contested by the Contractor who insisted on correcting all defects both on the road and on the ancillary works within two calendar months and duly accepted by the Client (GHA). The Contractor made efforts as per the above arrangement. Photographs of some of the defective as well as their

correspondent reworks are shown in the photographs attached.

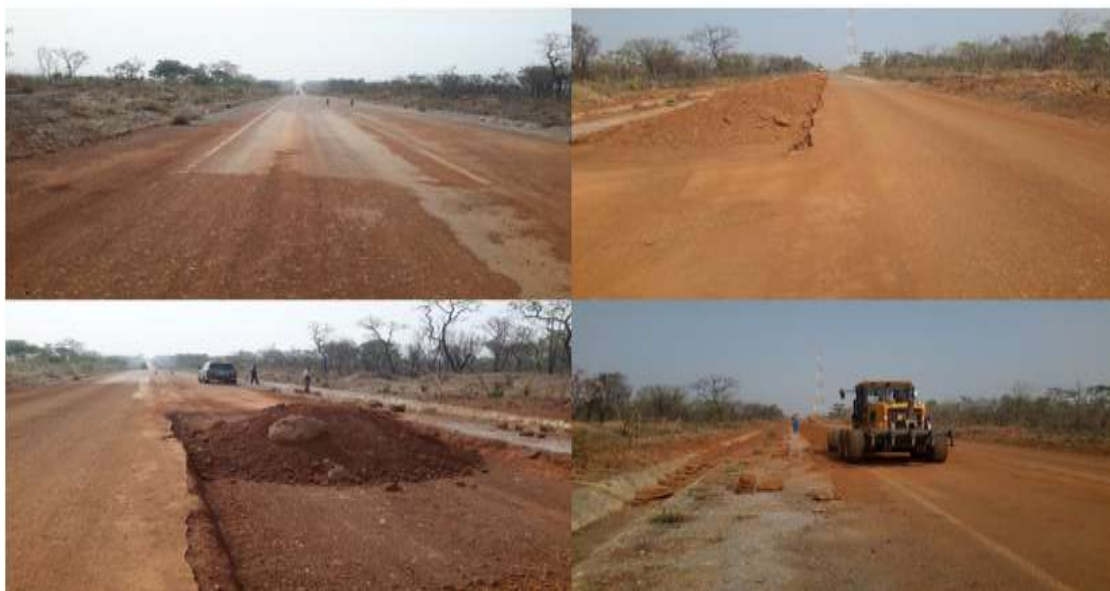
Figure 2. Shows the Contractor's Reworks and defects corrections
